HOUSATONIC RIVER BASIN,
DANBURY, CONNECTICUT.

WEST LAKE RESERVOIR DAM
(CT 00070)

PHASE I INSPECTION REPORT
NATIONAL DAM INSPECTION PROGRAM

JULY 1980

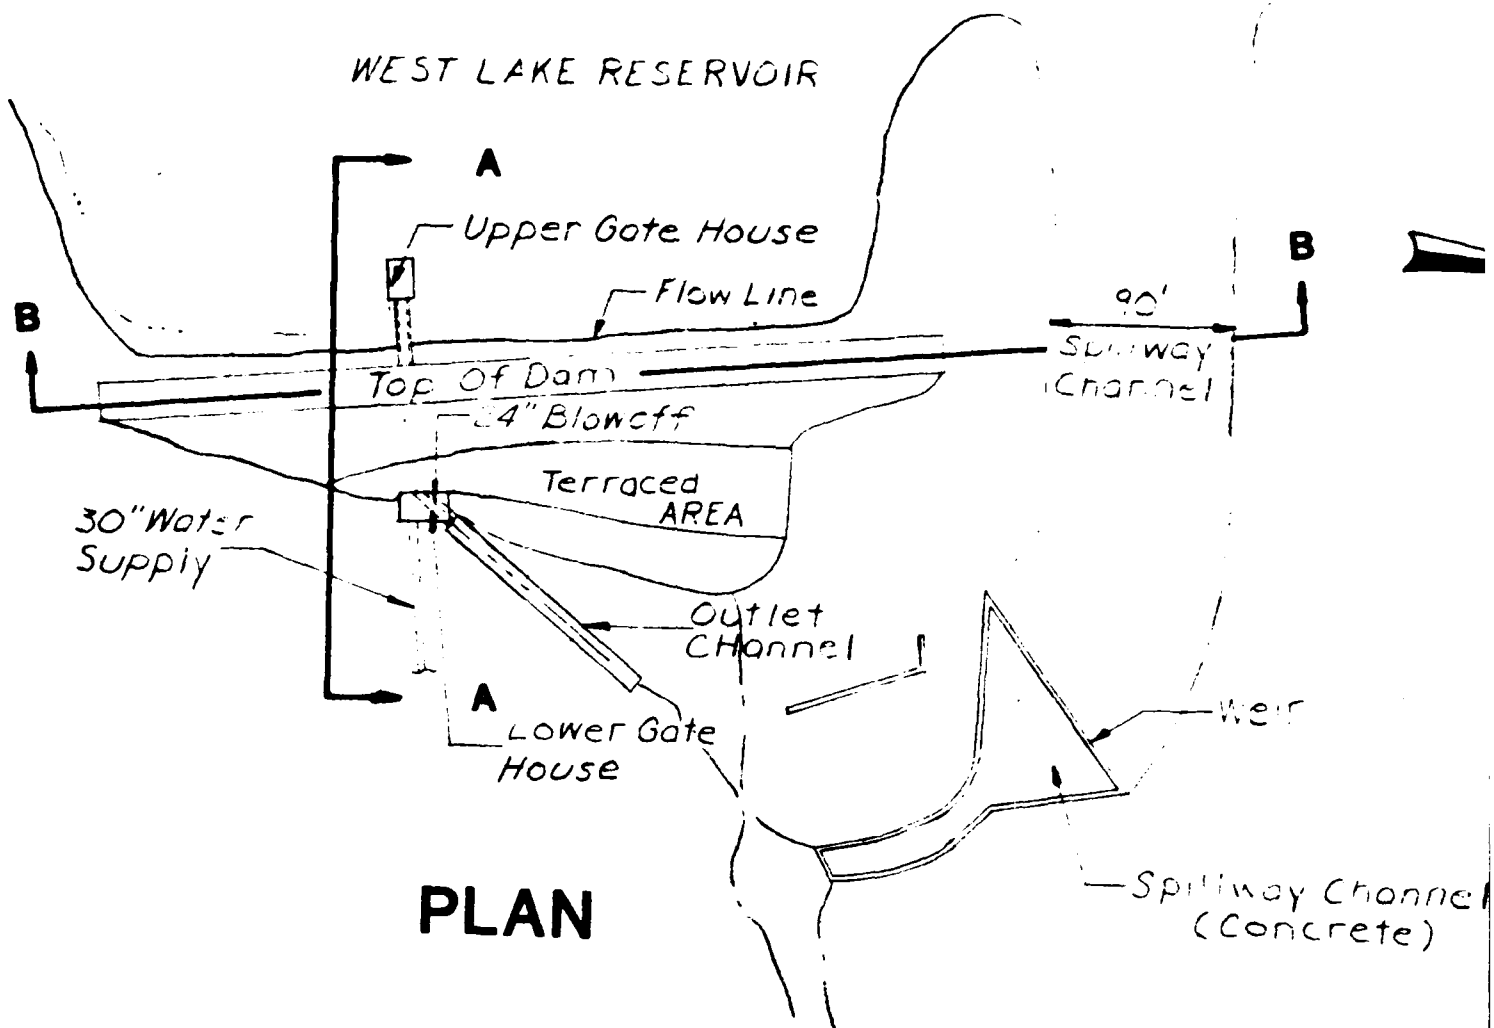
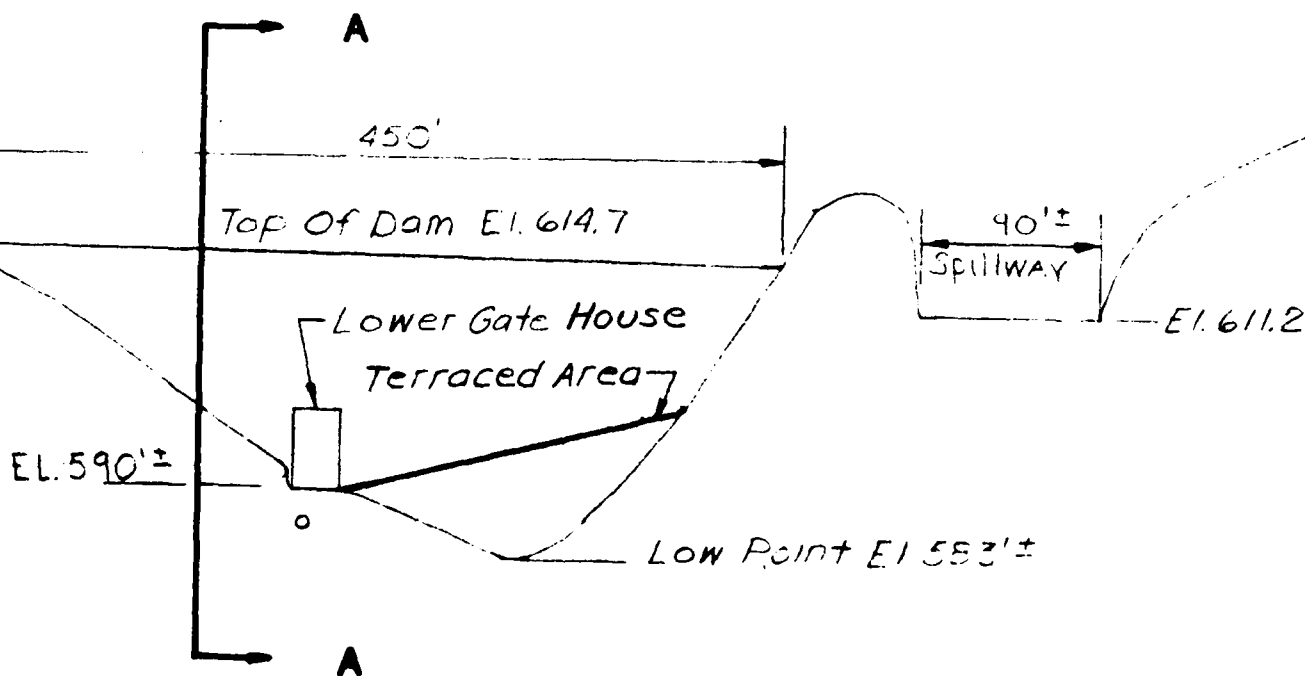
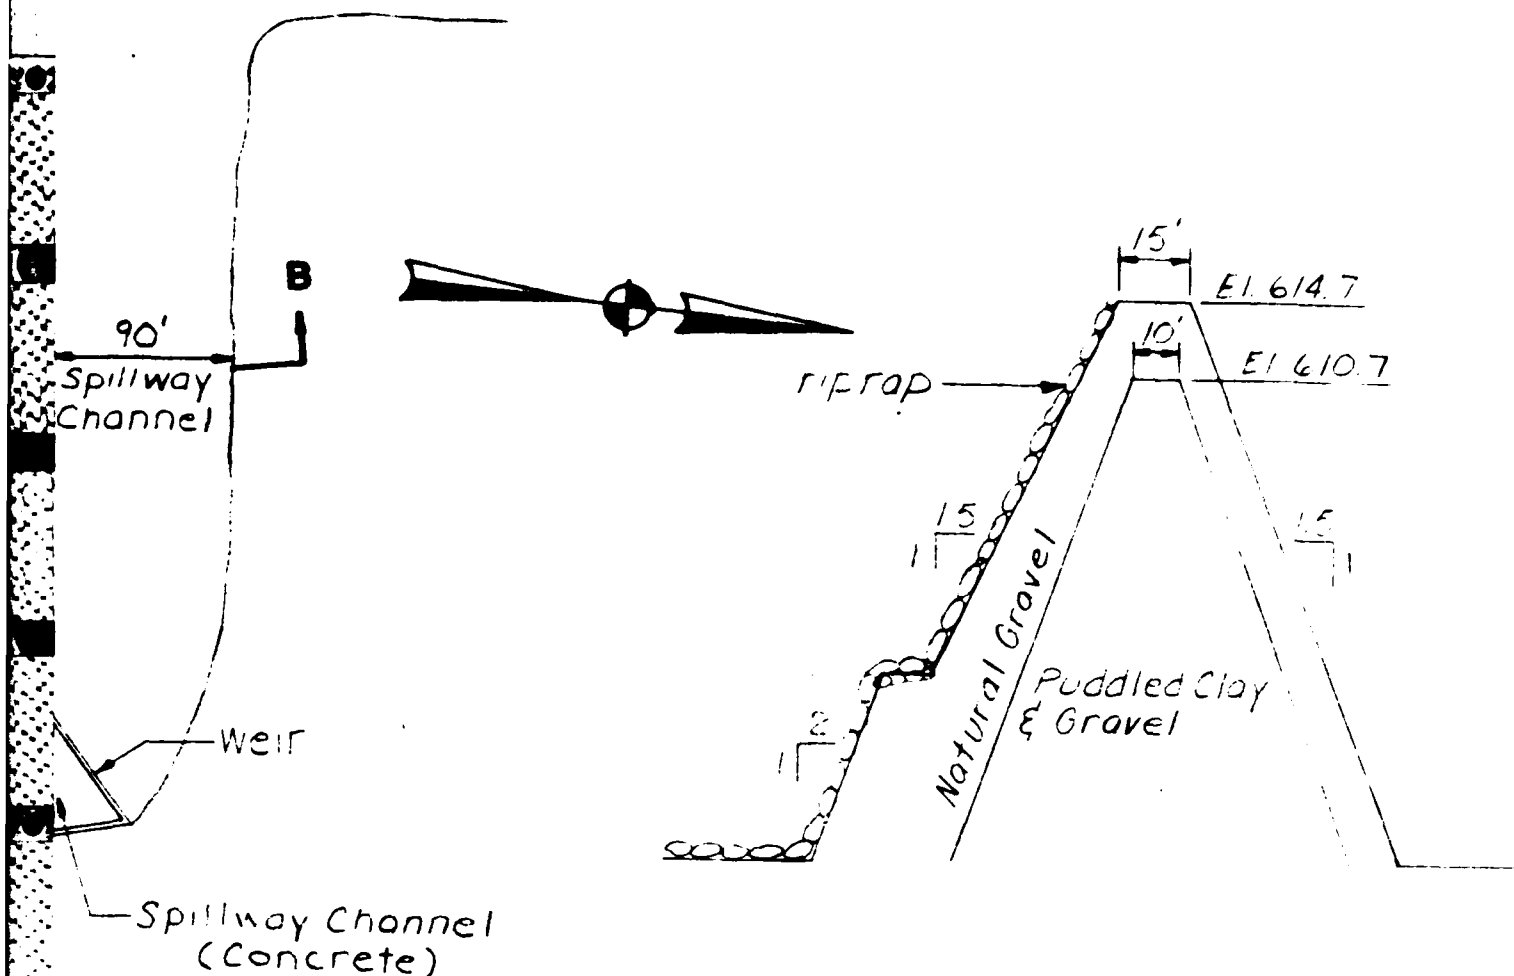
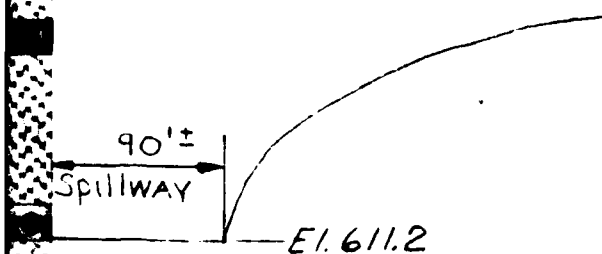
PLATE 1

No information on post-construction changes are available. However, comparing the drawings (sections) with actual conditions show a terraced area at the toe of the dam had been added (Appendix B - Plate 1).
